# FUTURE FISHERIES IMPROVEMENT PROGRAM

## BIENNIAL REPORT

Summary of program activities for the period November 1, 2016 to October 31, 2018

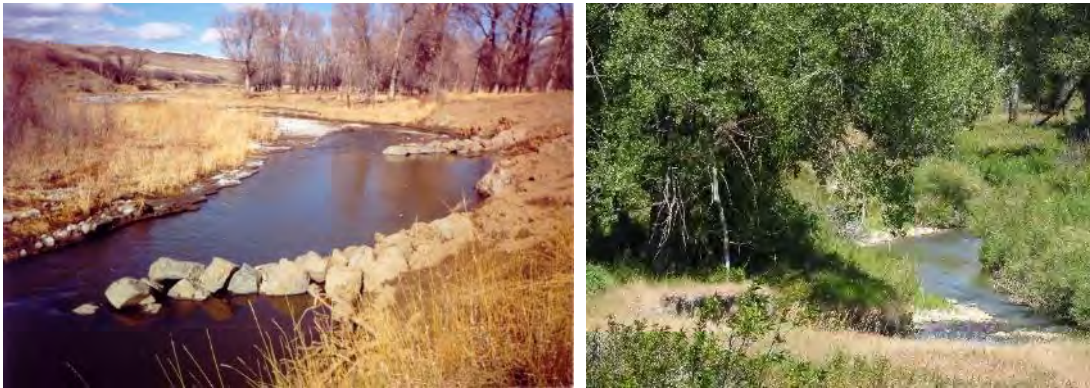
good condition and riparian area looks healthy. This project appears to have been successful in repairing the riparian area.

**FIGURE 121. COTTONWOOD CREEK IN 1999 (AFTER COMPLETION; L) AND IN 2017 (SLIGHTLY DOWNSTREAM OF PROJECT SITE, R)**

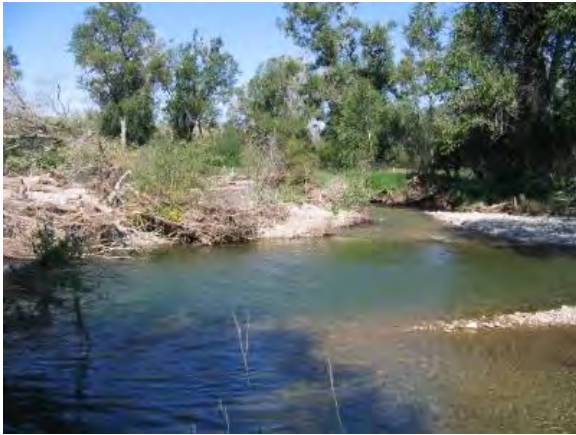
**FIGURE 122. PROJECT SITE IN 2011 (10 YEARS POST-CONSTRUCTION)**

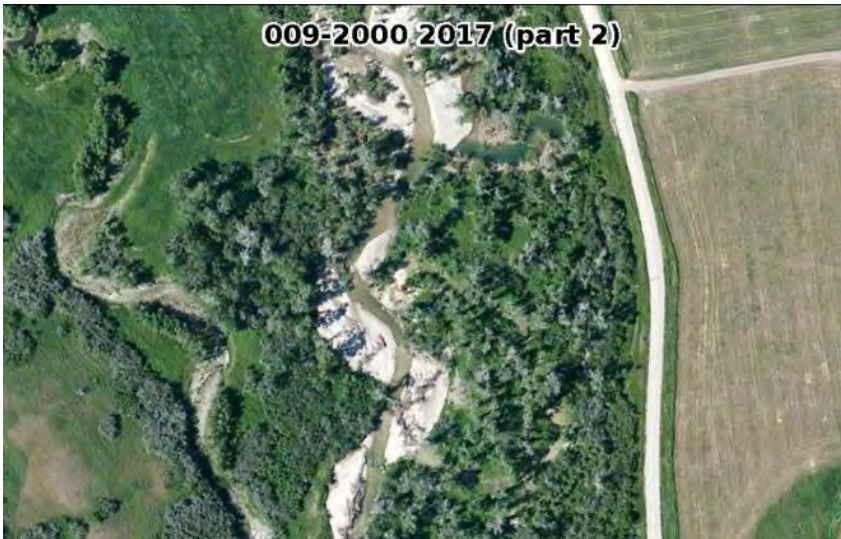
In 2017, the FFIPC met with the landowner, who was confused about the exact project location. Nonetheless, the landowner indicated that there have been dying cottonwood trees, meaning that the floodplain connection may be limited. Conditions upstream and downstream of the site showed erosion and some bank stabilization problems. Aerial photography showed topography in 2017 similar to 2011 conditions, when the channel straightened during a high flood event. At that time, riparian condition was considered good. This project may have improved erosion to some degree, but after a discussion with the local fisheries biologist, it appears the problems are much bigger in scope. Any additional improvements would need to consider the watershed. The project is considered minorly successful, and probably had most of the benefit before the 2011 channel adjustment. Lessons learned from this project include evaluation of the watershed and other limitations in project development.

**FIGURE 123. AERIAL VIEW OF SITE, 2017 (16 YEARS POST-CONSTRUCTION).**

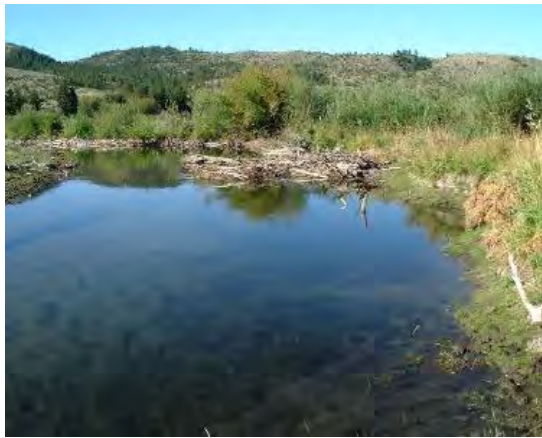
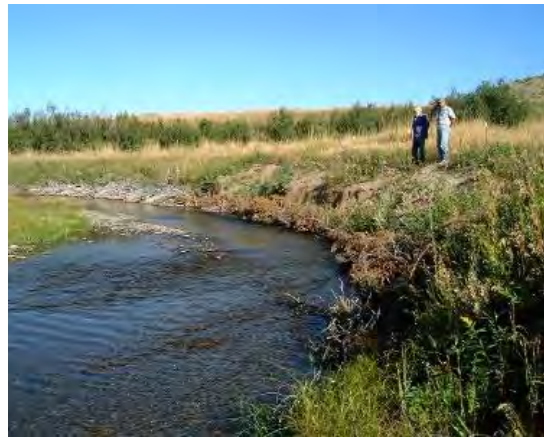
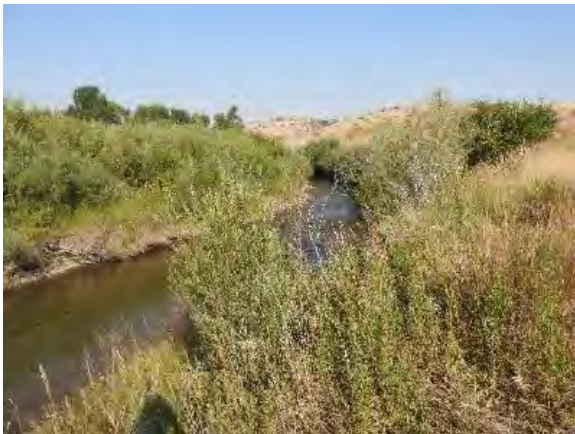
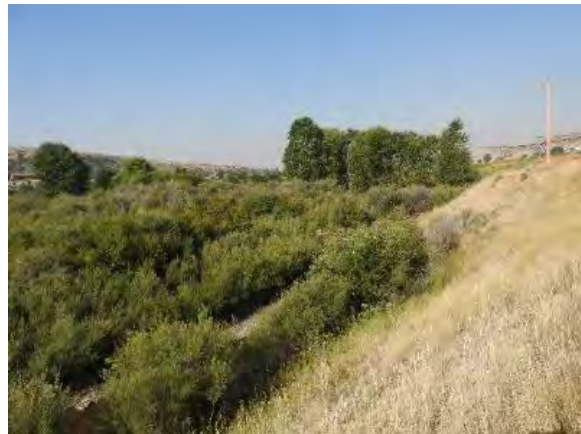
scour tends to be highest. Overall, the project appears to have been partially successful. However, the use of juniper revetments is no longer common practice due to its rate of failure. Additionally, rock toe was not part of project and that may have kept banks in place for a longer period.

**FIGURE 124. DEEP CREEK PROJECT SITE, COMPLETED IN 2004.**

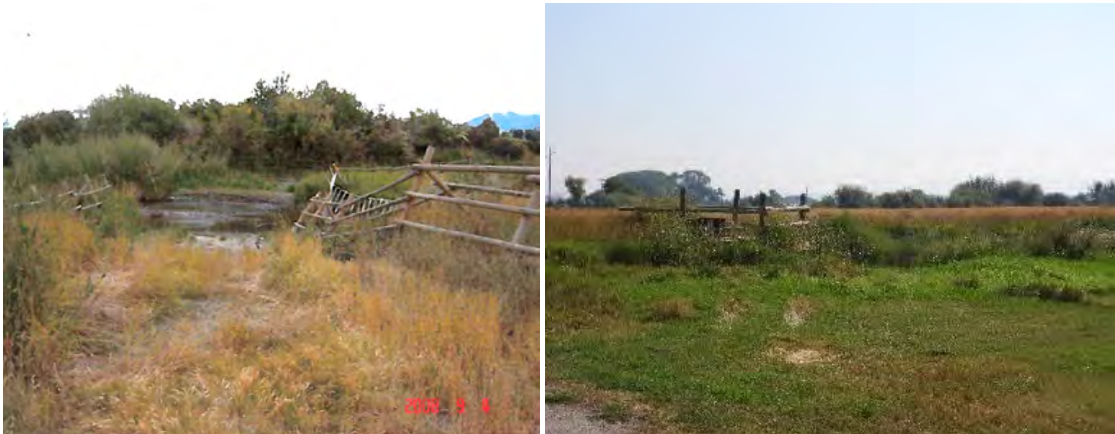
It has been very successful in reducing the impact from livestock. This project is part of a larger watershed effort to improve Deep Creek.

**FIGURE 125. DEEP CREEK PROJECT SITE IN 2008 (PROJECT COMPLETION, L) AND 2017 (9 YEARS POST PROJECT, R). WATERGAP AND OFF STREAM WATER.**

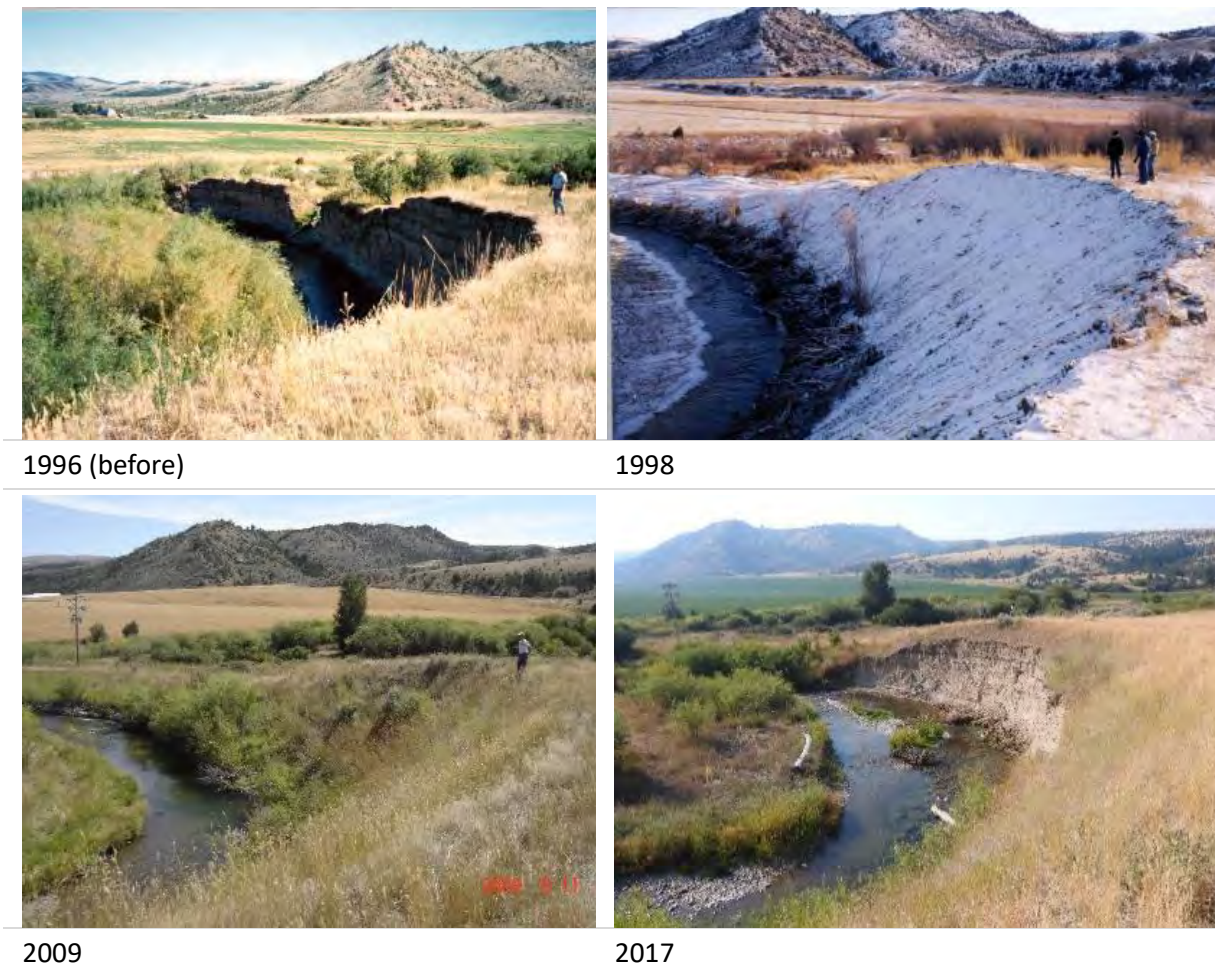
In 2009, the riparian condition was excellent with no observed livestock use. Stabilized banks were mostly retained, and willow recovery was considered good. There was one observed bank slump and it was noted that there could be some future erosion in the area. By 2017, the specific site had experienced extensive erosion and a vertical bank was again present (Figure 124). The primary method of bank stabilization used in this project was juniper revetments, which have washed out in most places that they were installed, especially in high risk areas such as meander bends.

This project had high success for at least 10 years, but by 20 had reverted to an erosive bank. The degree of success is hard to determine based on the duration of this project. It is considered moderately successful because it created a benefit for over 10 years. However, the lessons learned concern the use of juniper revetments for long-term bank stabilization. That specific treatment has largely been replaced with more effective methods. This project also shows how a small area of maintenance can unravel a project without intervention or repair. Had the small area of erosion been repaired, much of the bank treatment may have stayed in place.

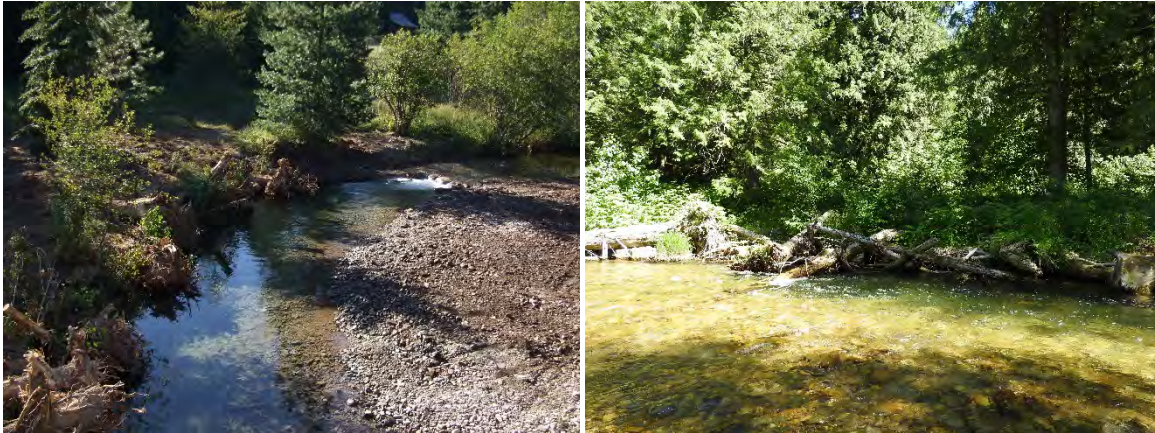
When the project site was visited in 2018, it was largely intact and functional. Much of the wood in the banks and as grade controls were retained, which is notable for a 10-year-old project in a high energy stream system. This project is considered highly successful in meeting its objectives of moving the stream away from a slide and incorporating stability and habitat complexity.

**FIGURE 128. EAST FORK BULL RIVER CHANNEL STABILIZATION AFTER CONSTRUCTION (L) AND IN 2017 (R).**

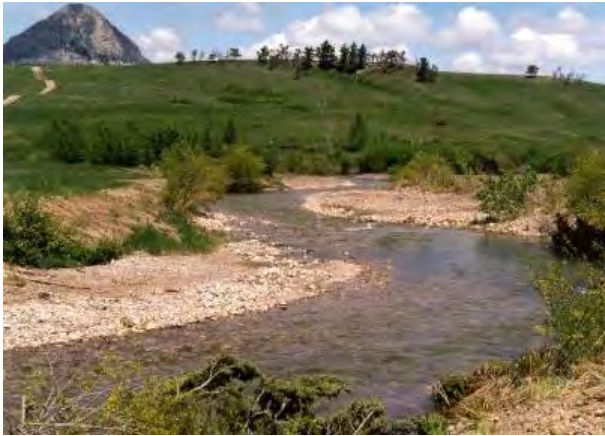
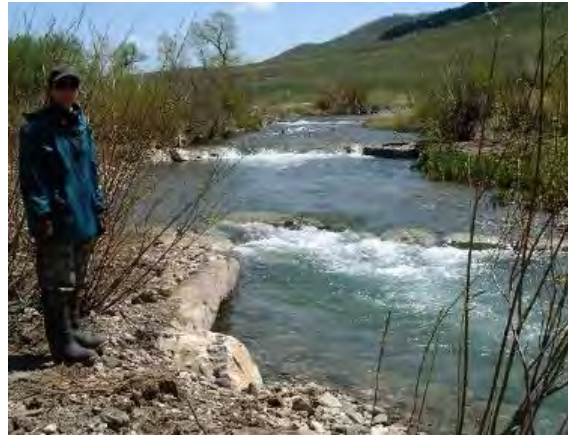
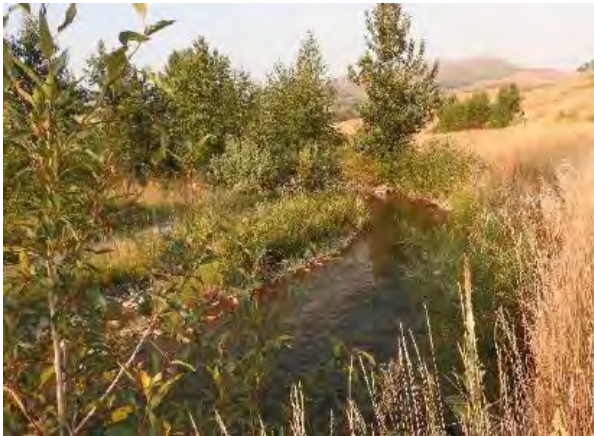
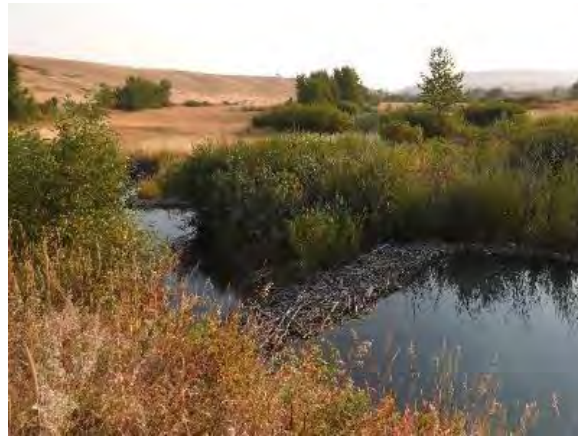
**FIGURE 129. ELK CREEK RESTORATION PROJECT, 2000-2017.**

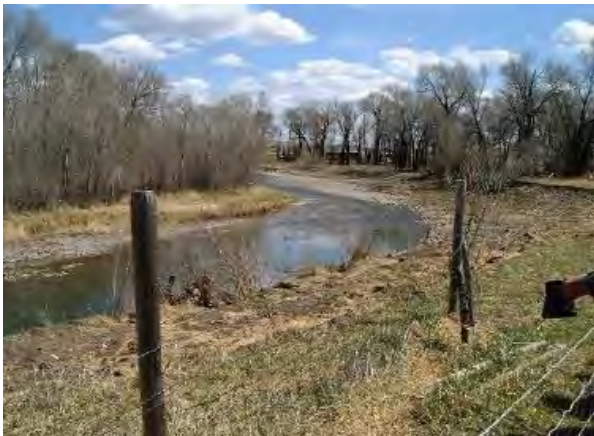
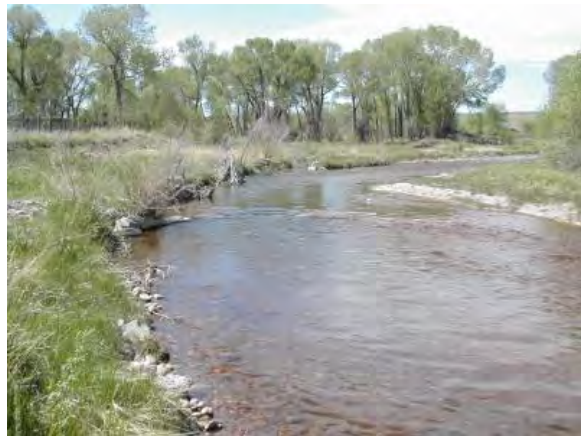
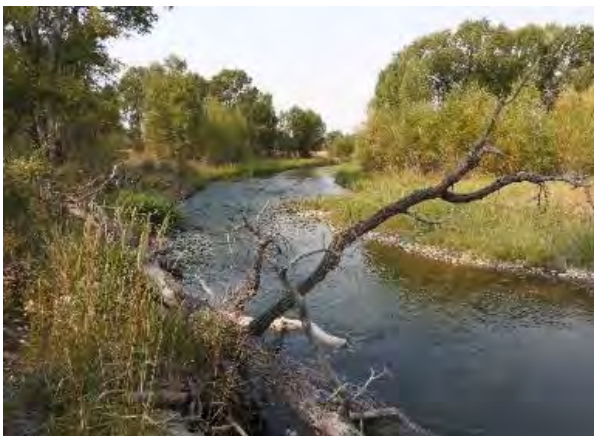
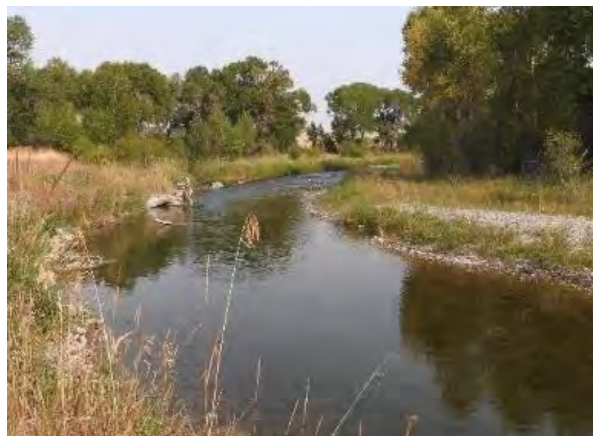
In 2001, fencing was installed. The goal was to improve water quality, reduce sedimentation, and improve the riparian corridor. In 2017, the project was in great condition with a healthy riparian area and little to no browsing by livestock. Past erosive areas were showing evidence of healing. This project is considered successful from both the landowner and from the FFIP. It is being managed as intended with healthy riparian and stream areas.

were prevalent throughout the observed reach. The landowner was not present, so it is unclear how the project area is managed. Overall, this project is considered successful in meeting its original goals and objectives. Weed management could improve its efficacy.

**FIGURE 130. ELK CREEK CHANNEL RESTORATION, 2000-2017.**

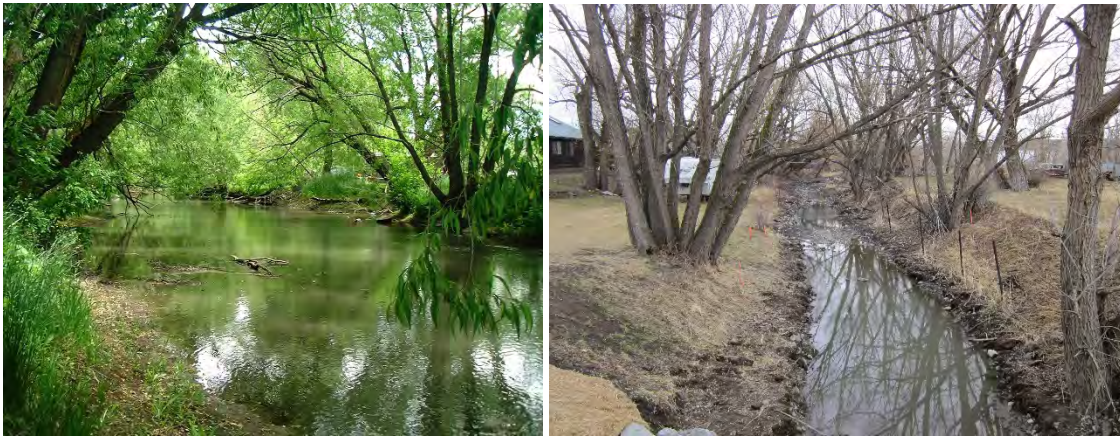
**FIGURE 133. FLESHMAN CREEK BEFORE (2010; L) AND AFTER (2015; R) CONSTRUCTION.**

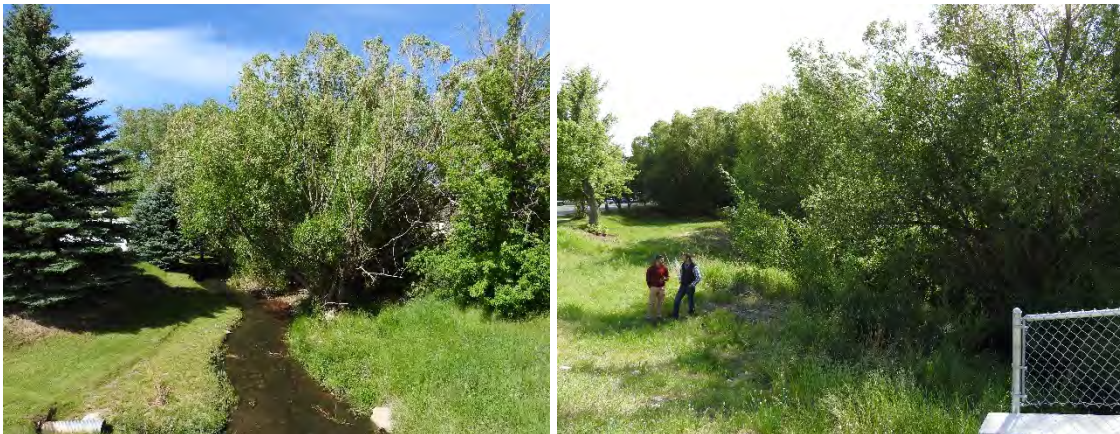
Several site locations were visited in 2017 as part of a FFIP project tour. The project appeared to be generally successful but because it is in the town of Livingston, there have been a few issues including erosion and mowing grass too close to the stream (Figure 134). Overall, this project has been successful in mitigating flood-related impacts and reducing water quality degradation from the city of Livingston. Although there are minor issues, they are generally related to the location of the project in an urban area.

**FIGURE 134. FLESHMAN CREEK IN 2017. MOWING ADJACENT TO THE STREAM (L) AND ABUNDANT RIPARIAN DEVELOPMENT (R).**

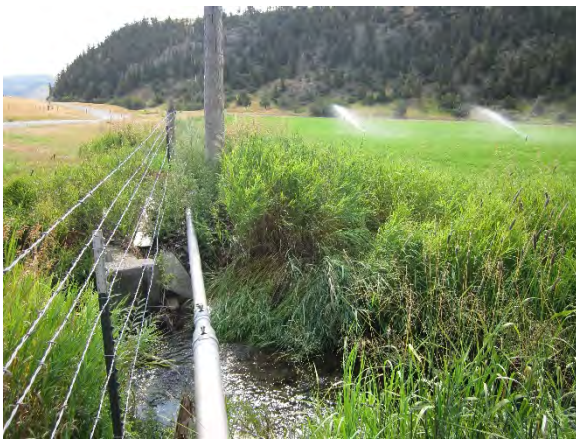
**FIGURE 136. LOCKE CREEK IRRIGATION, 2017.**

installed and in use, with the wheel lines running (Figure 136). Currently, the owners no longer divert any water from the stream.

Although the current operation varies from the original application, the original intent of keeping water in the stream has been maintained, making it an overall successful project. The needs of the landowners were balanced with the goals of the program, which is the best way for FFIP to be successful long term.

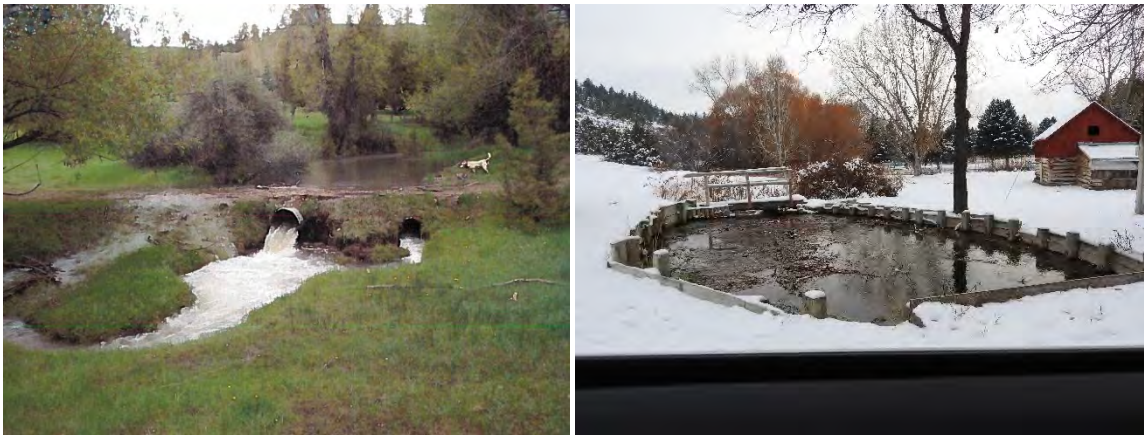
FIGURE 137. MAGPIE CREEK BEFORE (L) AND AFTER (R; 2017).

In 2017, part of the project was observed at the Norwegian Wood golf course. According to Eric Roberts, the fisheries biologist, two bridges were supposed to be constructed and only one was constructed and in place. The second location had the existing culvert wash out and a headcut developed before the bridge was installed. The second bridge has either been put in place or will be.

Overall, this project was successful in creating fish passage in Magpie Creek. The delay in the second bridge construction is disconcerting, and a follow-up is needed to ensure compliance.

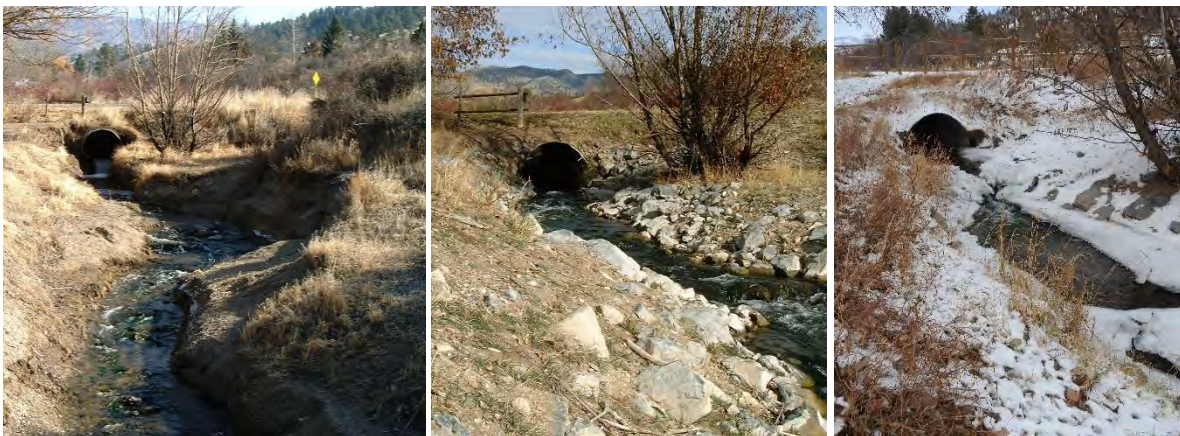
FIGURE 138. MAGPIE CREEK BEFORE (L; 2000), IN 2001 (C), AND IN 2017 (R).

Magpie Creek (Lewis & Clark County) supports a spawning run of rainbow trout from Canyon Ferry Reservoir. A perched culvert at a county road crossing and a short distance upstream from the mouth, was a barrier to fish movement. This project installed a series of rock drop structures below the culvert that brought the level of the stream up allowed fish to pass through the culvert (Figure 138).

This project was monitored in 2017 and stream flow was sufficient for fish passage, but because the culvert was not embedded, there was concern that the culvert may impede passage at certain times of the year—particularly with high flow and limited resting spaces for fish. Fisheries biologist Eric Roberts noted that the rock ramp is functioning as intended. Overall, this project has been successful in meeting its goal of installation and maintenance of a rock ramp to encourage fish passage.

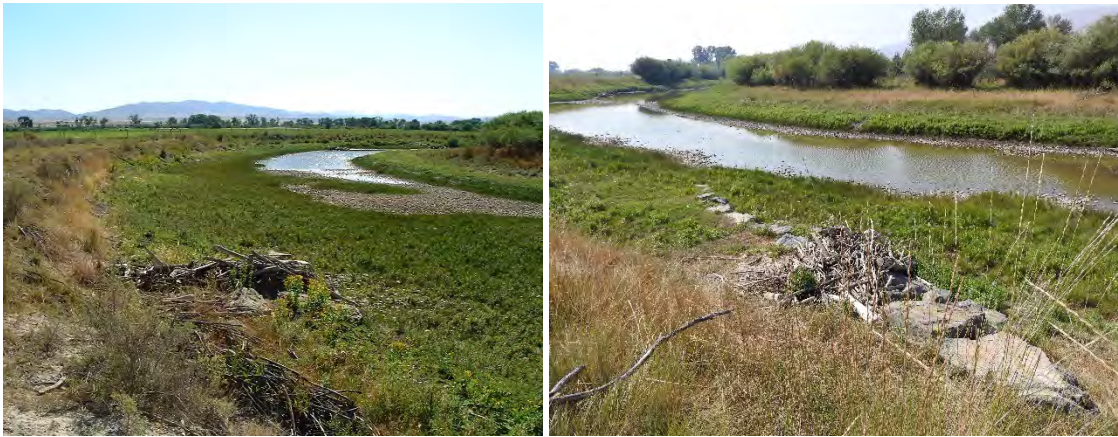
**FIGURE 140. MISSOURI RIVER SIDE CHANNEL IN 2004 (L) AND 2017 (R).**

In 2017, the site was visited with Ron Spoon, fisheries biologist. The side channel was essentially disconnected from river, which has been the case since the early 2000s (Figure 140). It is likely that significant flow reaches site only in high water events. Aside from the wetland value, this project has no fishery benefit. The installed structures remain in place but are now vegetated and unused. Grazing still occurs, although it likely has minimal impact to fishery at that location. The project was unsuccessful because the side channel was abandoned. Future projects should consider likelihood of channel movement, if possible. This project is now expired, having reached its 20-year life.

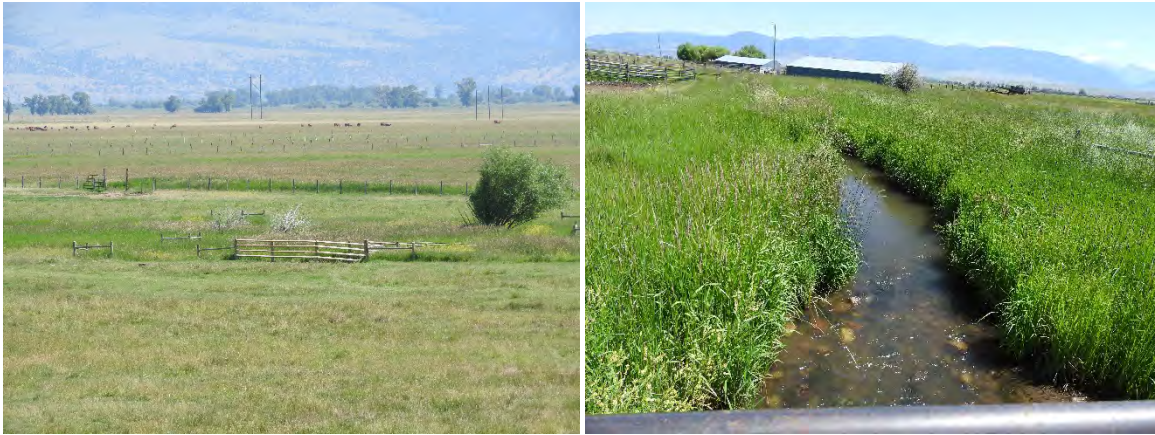
**FIGURE 141. MOORES CREEK ON THE GOGGINS RANCH, 2018.**

In 2018, the site was visited with Sunni Heikes-Knapton, Madison Conservation District Administrator (Figure 141). The entire project was viewed from hospital parking lot and in-depth at the Goggins Ranch. Since completion, vegetation has been established and the ranch continues to operate as needed. Overall, the project has been successful in maintaining a vegetated channel with protection from livestock, while also meeting the needs of the ranch.

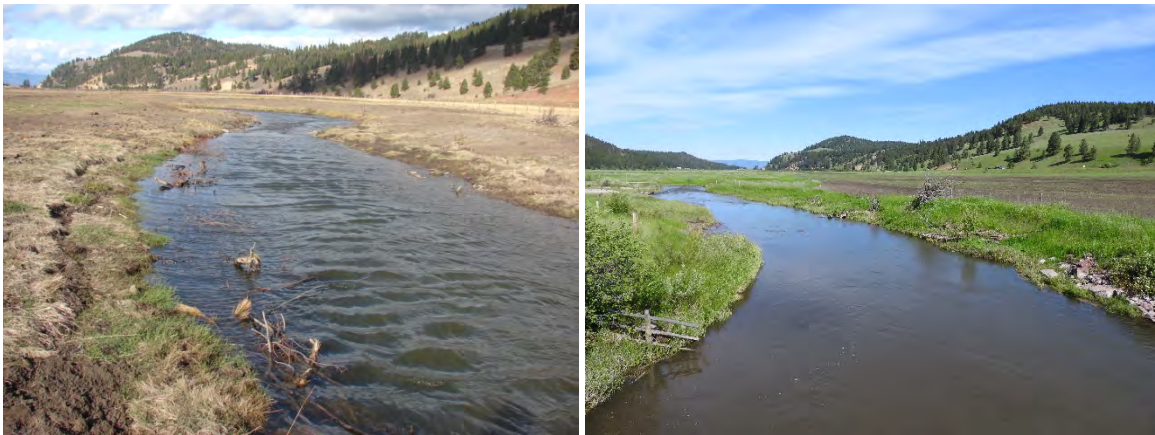
**FIGURE 142. NEVADA CREEK BEFORE (L) AND AFTER (2018; R).**

In 2018, as part of a FFIP tour, the channel reconstruction and fencing components were monitored for long-term effectiveness. Despite high flows after construction, the channel has largely retained its shape/stability. There have been some repairs done to areas that began to unravel, but the project has been successful overall in retaining an appropriate channel configuration. Its location downstream of a reservoir is not helpful when it comes to mobilizing sediment. Electric fence is being used, and although the riparian buffer is not as large as desired, it serves the needs of the ranch. This project has great demonstration value in the drainage. Recent work has been completed and proposed by the Big Blackfoot Chapter of Trout Unlimited to continue the restoration work downstream.

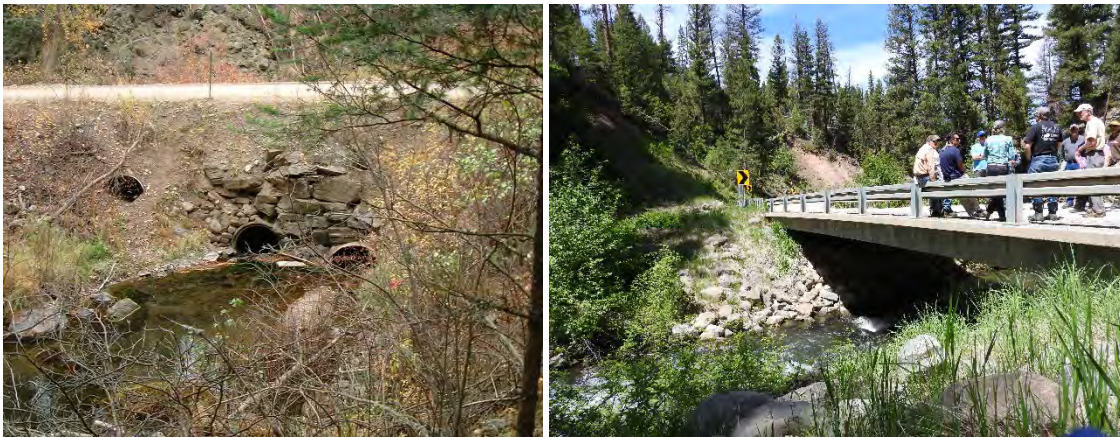
FIGURE 143. POORMAN CREEK CULVERT (2002; L) TO BRIDGE (2018; R).

Poorman Creek (Lewis & Clark County) supports a mixed salmonid fishery that includes bull trout as well as genetically pure westslope cutthroat trout. A pair of culverts located approximately three miles upstream from the mouth were barriers to fish migration. This project involved replacement of the existing culverts with a bridge (Figure 143).

In 2018, this site was visited as part of Future Fisheries tour. The bridge is easily accessible, in good condition, and appears to have been very successful in improving migratory corridors.

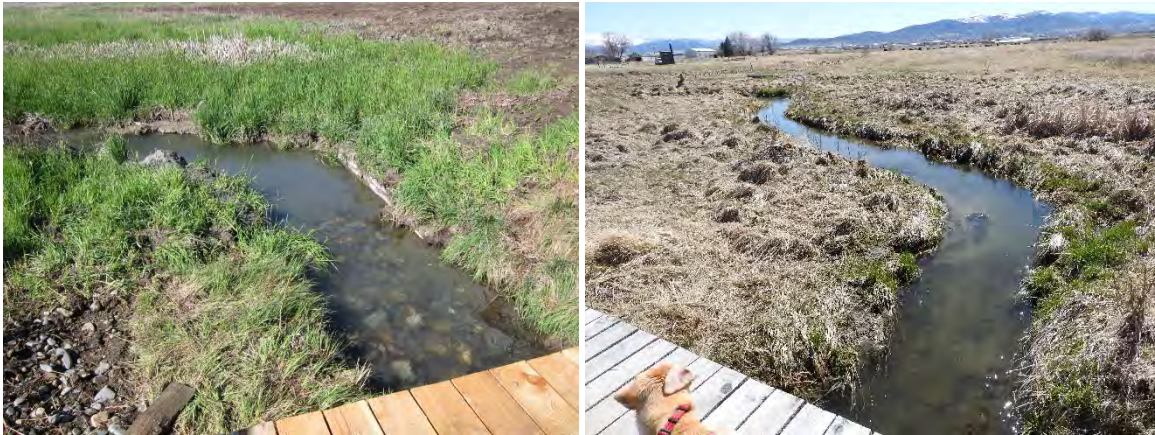
**FIGURE 144. UNNAMED TRIBUTARY TO PRICKLY PEAR CREEK AFTER CONSTRUCTION (2015; L) AND IN 2018 (R).**

The site was visited in 2018, and the project appeared to be functional in several places with vegetation growing and becoming established. However, erosion occurs in several places of Prickly Pear Creek. The stream may be making adjustments and it may need to be monitored again in the coming years. The Spring Creek portion looks good with exposed gravels. The project has been a success.

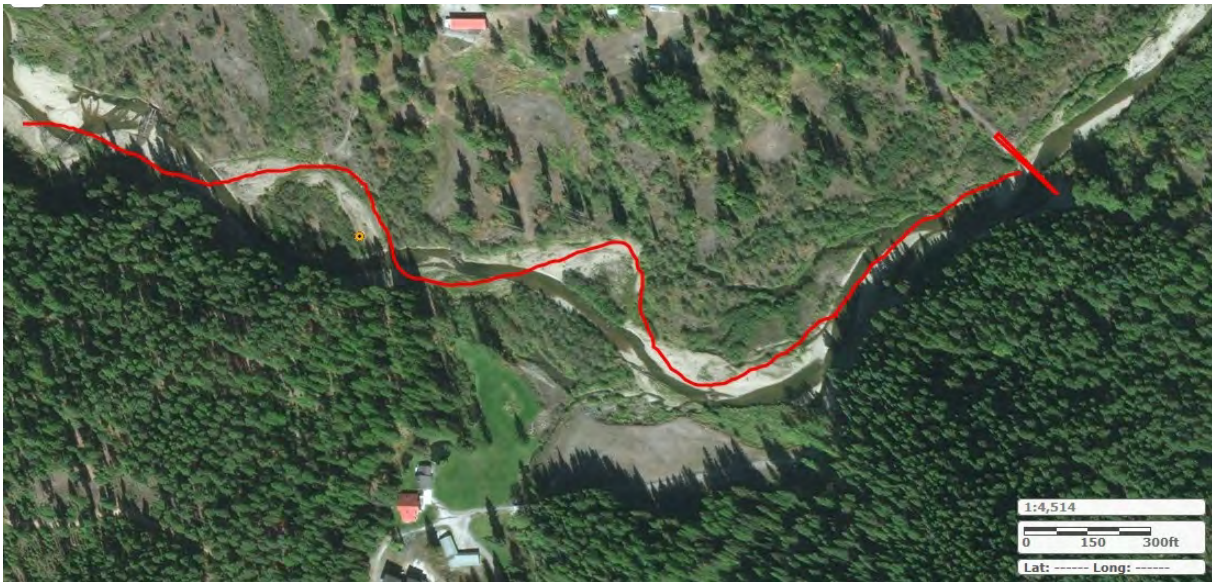
**FIGURE 145. CHANGES IN PROSPECT CREEK CHANNEL 2005 (RED LINE) TO 2017 (AERIAL BACKGROUND).**

In 2018, this project was visited from public roads, but not all photos could be replicated. It was difficult to determine where the treatments were installed. However, 2009 monitoring indicated that the stream moved away from treated reaches, which could explain why the FFIPC was unable to determine where habitat improvement took place. The structures are most likely gone or abandoned. Aerial photographs are most useful to show the evolution of the project in the last 18 years (Figure 145).

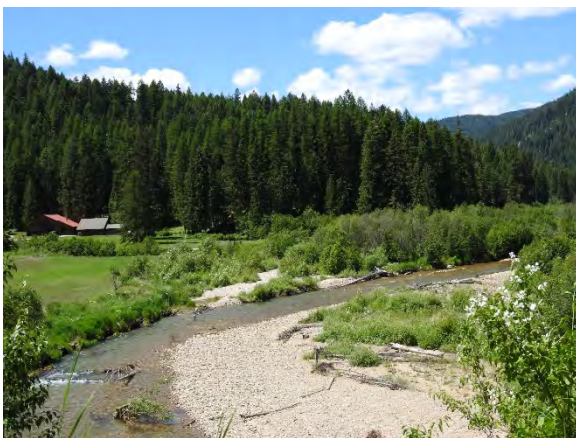
**FIGURE 146. AN EXAMPLE OF PROSPECT CREEK, WITHIN THE PROJECT AREA (2018).**

Prospect Creek is a dynamic system dominated by cobble (Figure 146). Erosion is unlikely to be a large issue in terms of sediment input and is more likely a concern for landowners in the floodplain. The stream appears to be moving fairly actively within its floodplain and is likely significantly affected by downed trees and other debris in the floodplain. The riparian area is overall highly vegetated, and livestock does not appear to be an issue. The project was not successful in its original design, but the stream appears to be mostly functional within its floodplain. The lesson learned is to avoid stabilization techniques in areas with significant channel movement within a floodplain.

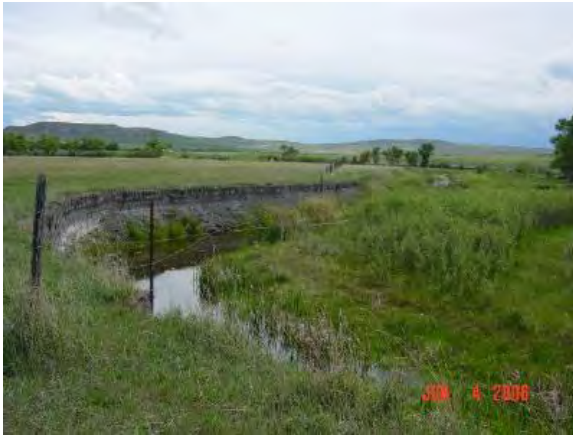
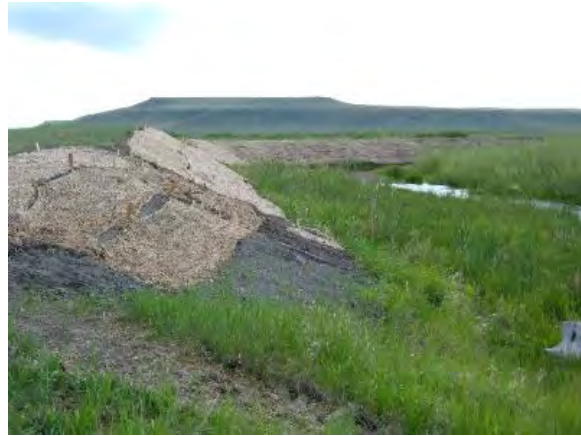
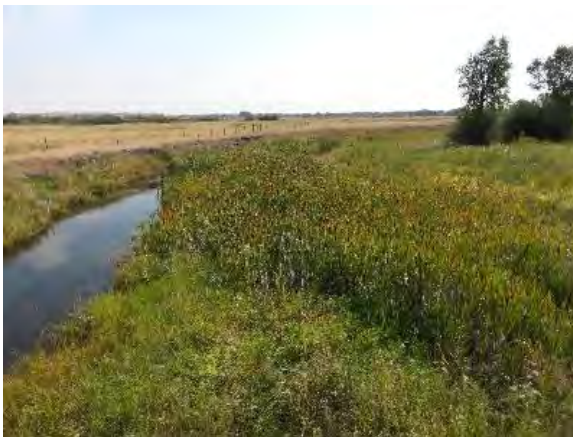
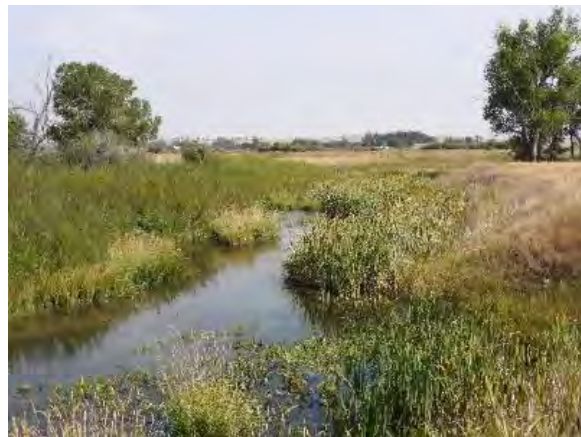
**FIGURE 147. TETON CREEK BANK STABILIZATION, 2006-2017.**

The Teton River (Teton County) near Choteau supports an important local fishery for rainbow trout and brown trout. This project stabilized stream banks on a section of school trust land that was overgrazed by back-sloping, planting willow clumps and sprigs, seeding with native grass, installation of electric fencing, and installation of erosion control fabric. Approximately 900 feet of stream bank was treated (Figure 147).

In 2017, the project site was in good condition. The fencing was intact and protecting the stream. There was very little disturbance observed on the property. The treatments appeared to have been successful; the stream has narrowed and created a wetland area in the floodplain.

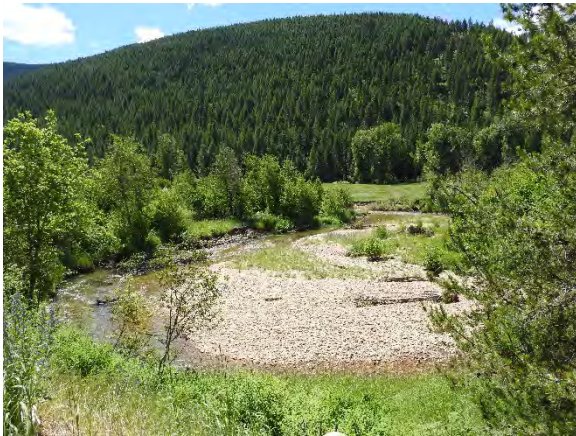
**FIGURE 150. WHITE PINE CREEK (2018), A HIGHLY MOBILE SYSTEM.**

Ryan Kreiner, fisheries biologist, noted that this is a very dynamic system and the stream actively moves within its floodplain. The aggradation/degradation appears to be balanced with high input of trees that likely shape the channel on a regular basis. The project may have been initiated to address infrastructure (homes and properties in the floodplain), but the stabilization was not completely effective. The project was repaired in 2004 but was ultimately unsuccessful.

The site was visited in 2018 and it was evident that the channel had been actively shifting in places (Figure 150; Figure 151). The landowners have been frustrated with the dynamic system so close to their homes. Although it is considered an unsuccessful project, the lessons learned are that bank stabilization isn't successful in highly mobile systems that experience constant fluctuations. A consideration of this program should be placed on allowing a stream to move within its floodplain. Roads were highly armored in places, as the stream is actively putting pressure on some areas. Fine sediment is not likely to be a significant issue in this stream.

Ultimately, projects installing hard structures into dynamic streams should be avoided. Enhancements to these highly-mobile systems should consider the constant movement of the channel.
